# CABLE SUPPORT IN LONGWALL GATE ROADS

By Dennis R. Dolinar<sup>1</sup> and Lewis A. Martin<sup>2</sup>

## ABSTRACT

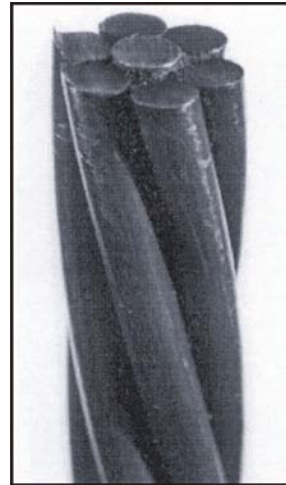
Figure 1.—Seven strand steel cable used to make cable bolts.

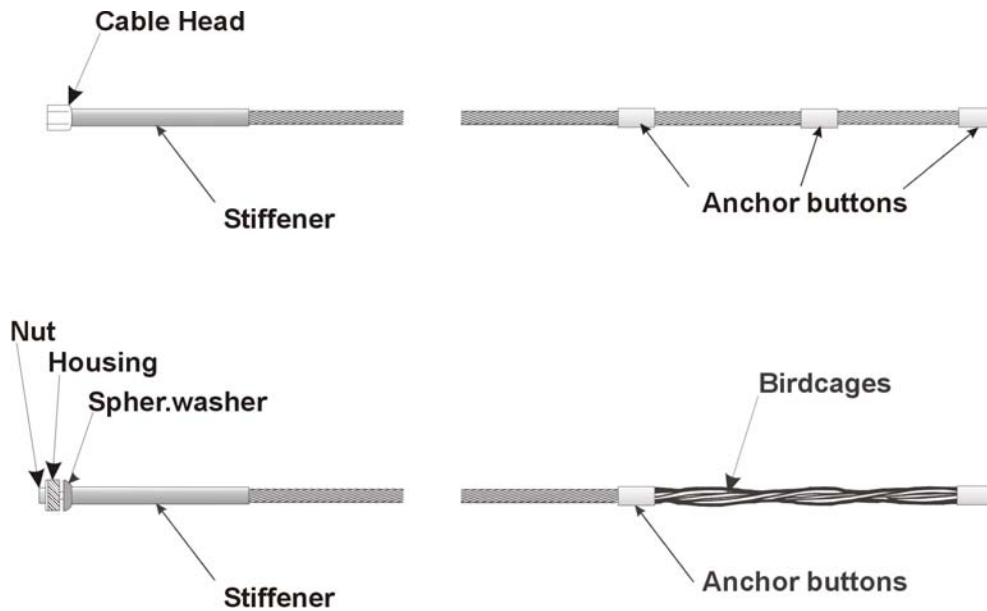
Figure 2.—Cable bolt and cable bolt components.

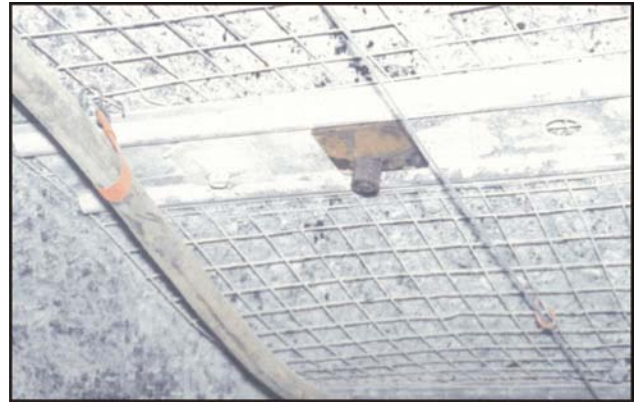
Figure 3.—Cable bolt system installed in a tailgate.

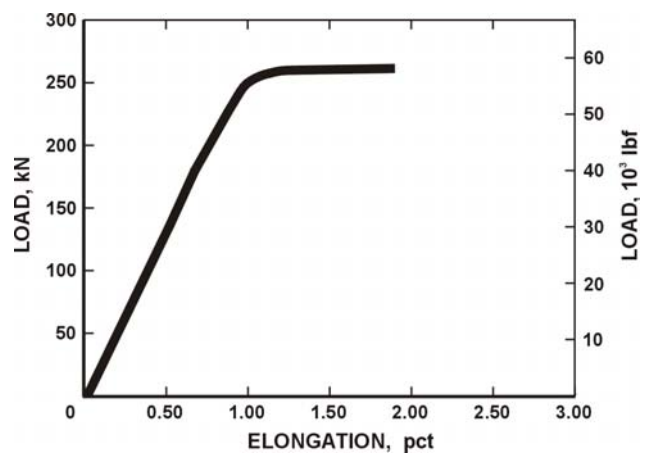
Figure 4.—Load-deformation curve from a laboratory tensile test of a cable.

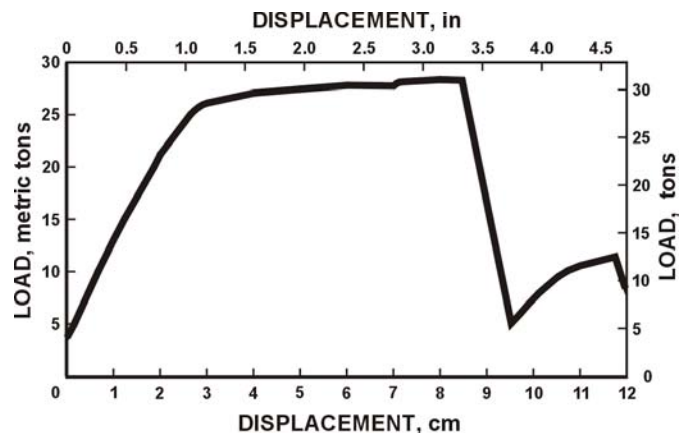
Figure 5.—Load-deformation curve from a pull test of a cable bolt underground.

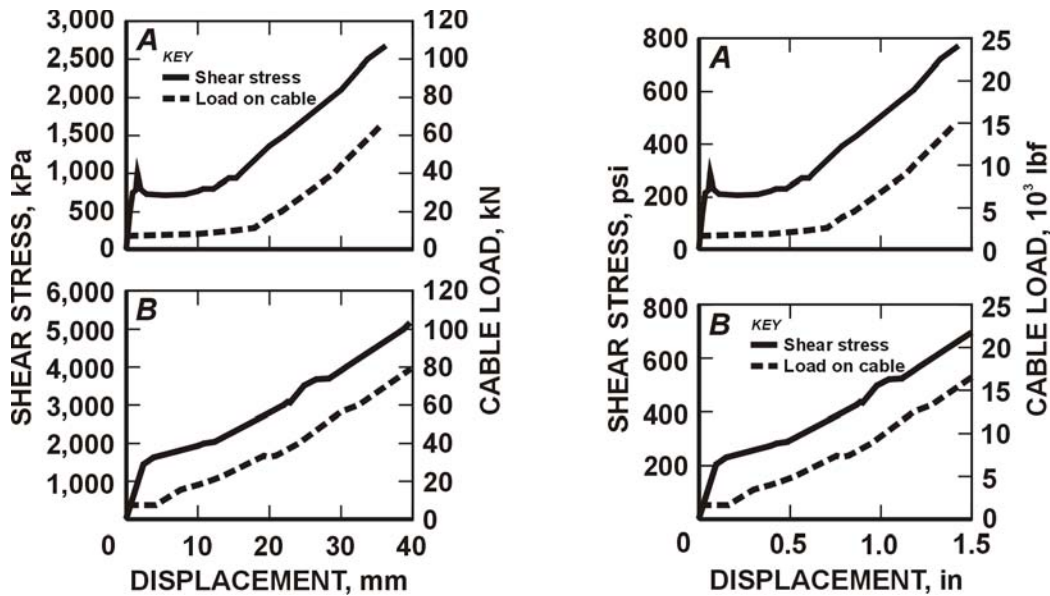
Figure 6.—Typical cable load and shear stress versus shear displacement A, smooth joint with cable bolt reinforcement and B, rough joint with cable bolt reinforcement.

In this series of tests, the maximum lateral displacement on the cables was about 3.8 cm (1.5 in). None of the cables failed as a result of this level of displacement. At this point, the cables were loaded to about 60 kN (13,500 lbf), still well below the ultimate strength. However, in a field study, where about 0.3 to 0.46 m (1 to 1.5 ft) of lateral movement occurred across the entry, several cable bolts had failed. It is estimated that the cable bolts failed at between 5 to 10 cm (2 to 4 in) of lateral movement [Dolinar et al. 1996]. The failures occurred from a combination of shear and tension.

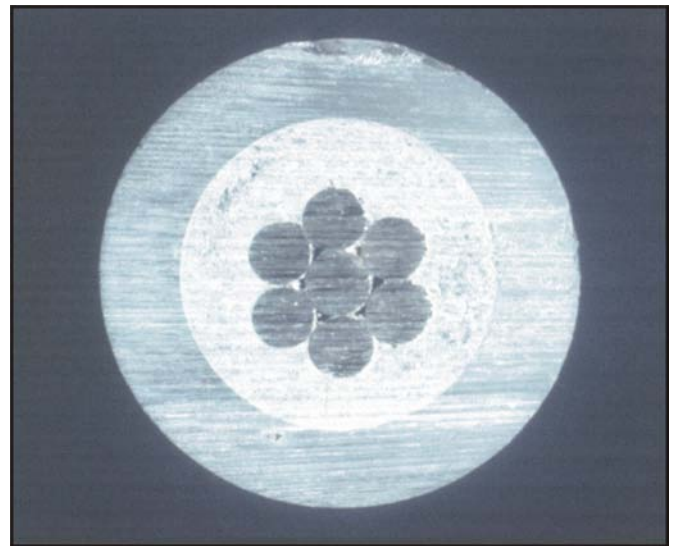
Figure 7.—Cross section of 1.52 cm (0.6 in) cable set in resin, installed in a 2.5 cm (1 in) diameter hole.

Several factors influence the effectiveness of the resin anchor, including anchor length, type of resin, and hole diameter [Zelanko et al. 1995]. Figure 7 shows a cross section of a cable installed in resin. The cables will transfer the load through the anchor to the rock with all the load transfer taking place within the anchor length. However, if the anchor is too short, the anchor could slip (rock-grout interface failure), especially in weak rock. With a longer anchor, the anchor

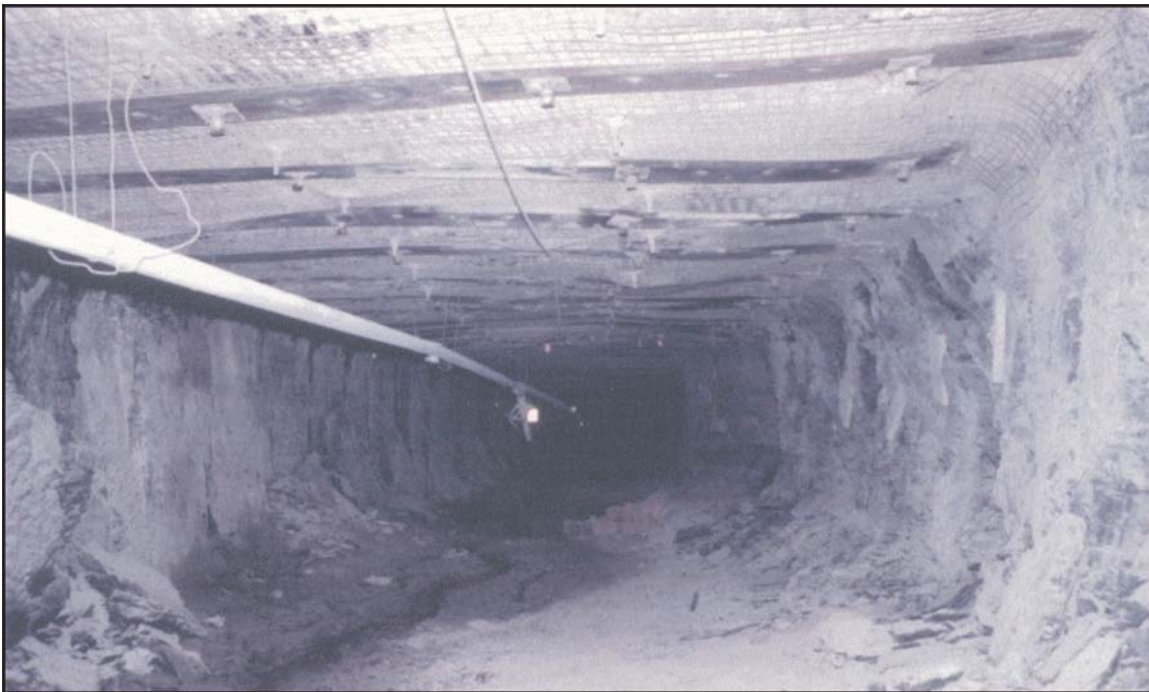
Figure 8.—Surface control in the form of a "Monster Mat" installed with cable bolts.

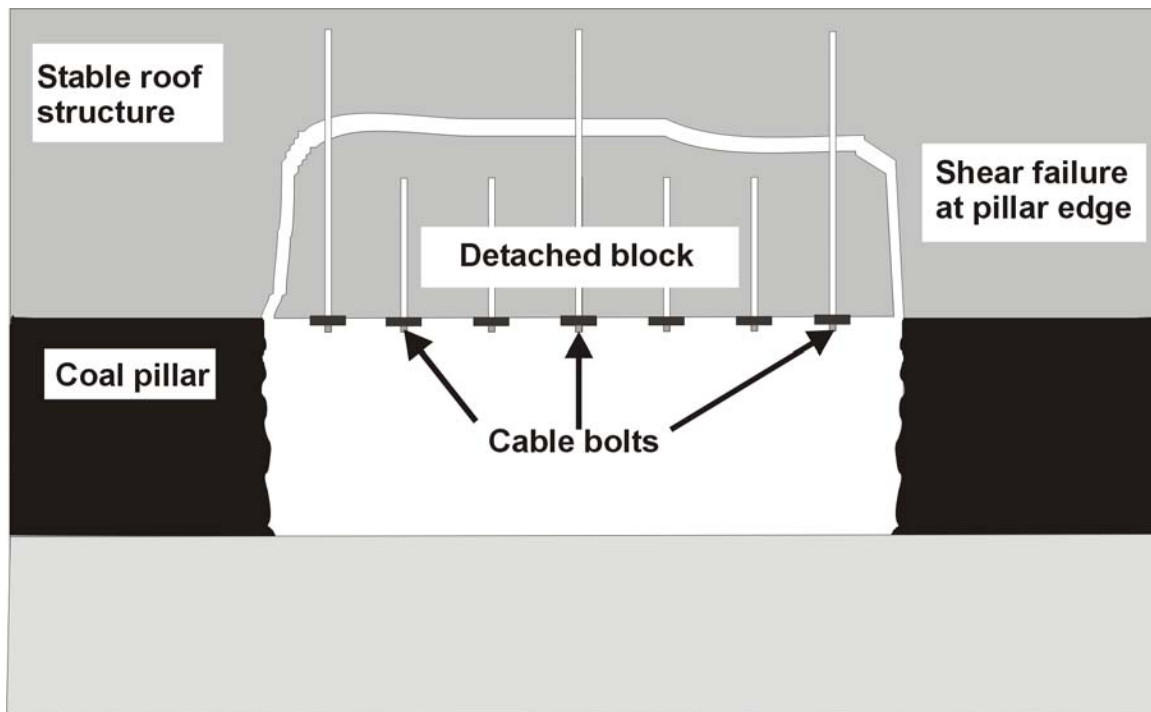
Figure 9.—Detached block of failed roof supported by cables.

For suspension, the simplest approach is to identify a parting plane or a flat-lying, potential failure plane above the bolted roof horizon where the roof will shear at the pillar edge of the opening and the entire weight of the rock must be supported as a detached block (figure 9). The weight of the material can be determined from the following equations.

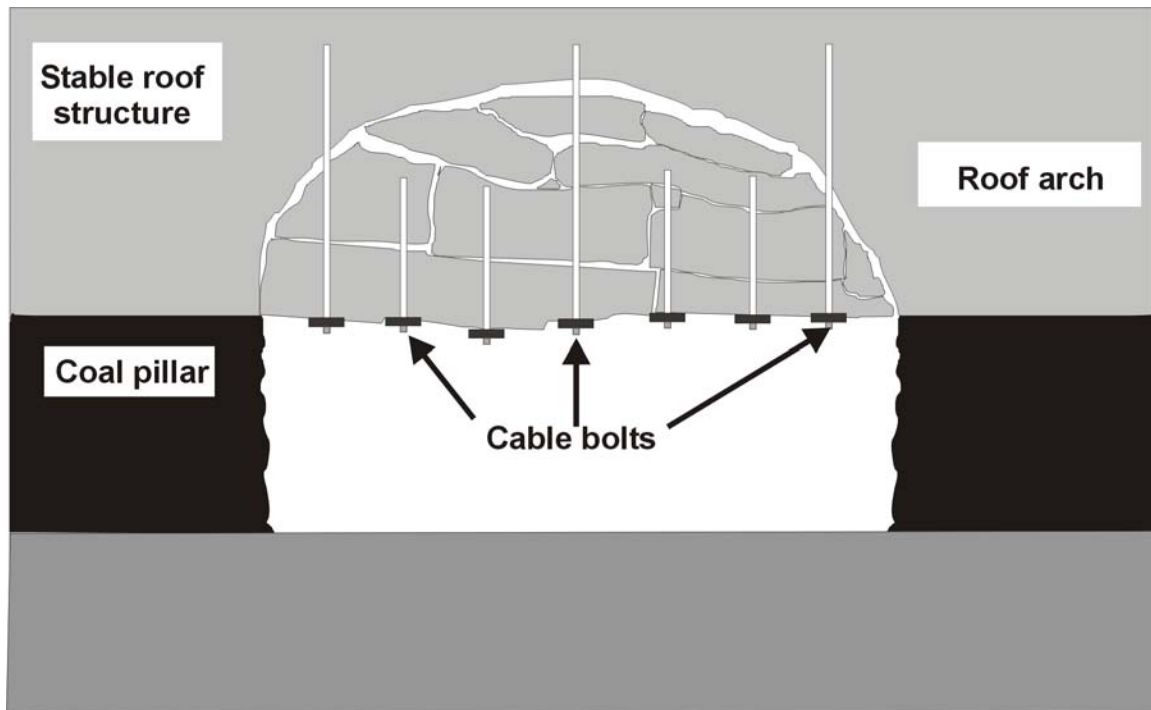
Figure 10.—Formation of pressure arch of failed mine roof material.

If an arched roof failure is formed with the pillars carrying some of the weight, the cables need only support the weight of the rock under the arch (figure 10). The height of the arch will be determined by a combination of the geology, as well as by the vertical and horizontal stresses acting on the roof and the induced mining stresses. Obviously, the length and the number of cables

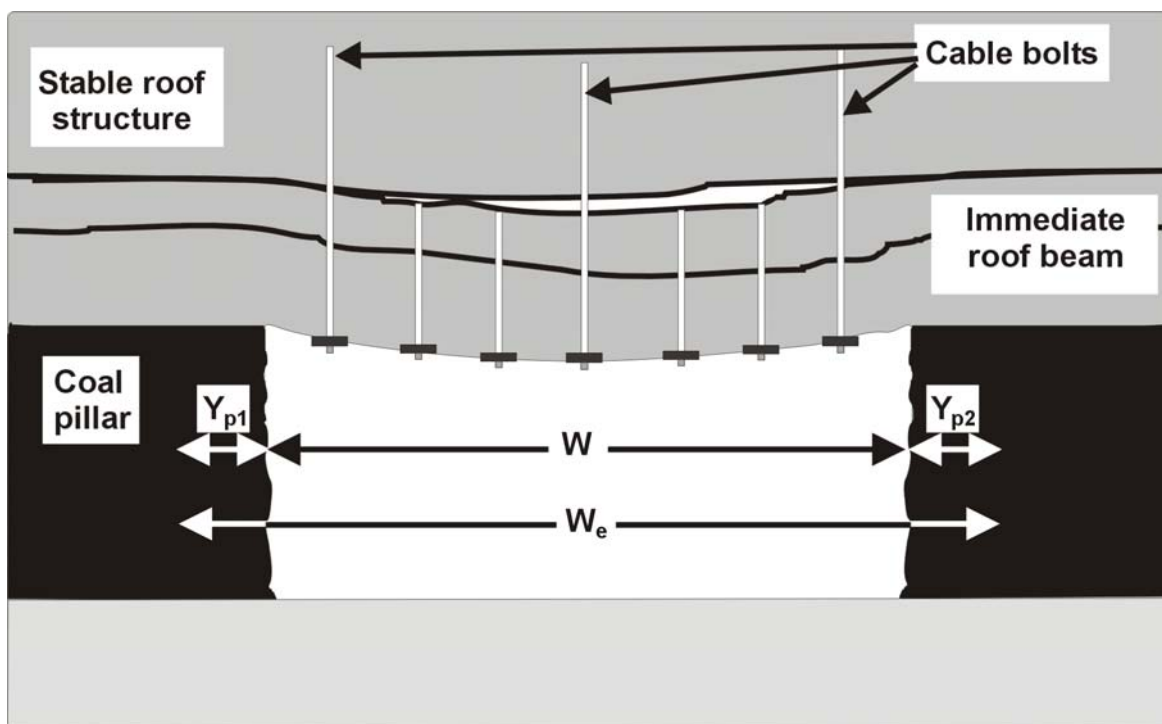
Figure 11.—Formation of yield zone in coal pillar, ( $W_e$  = effective width of opening;  $y_{p1}$  = yield zone of pillar 1;  $y_{p2}$  = yield zone of pillar 2;  $y_p$  = yield)

The behavior of the pillar under different loading conditions will affect the width of the opening and therefore the weight of the rock that must be supported (figure 11). The depth of the yield zone can be determined from equations developed by Wilson and depend on the strength of the coal pillar [Wilson 1972]. The following equations can be used to estimate the depth of the yield zone.  $w$  = pillar width in meters (feet).

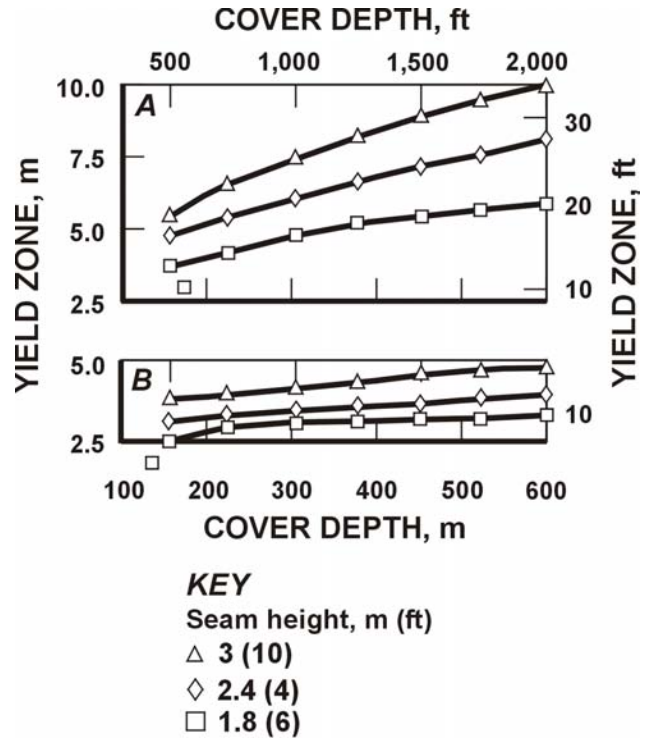
Figure 12. –Design chart to determine yield zone width in coal pillars. A, yielding roof; B, rigid floor.

Based on the weight of material that must be supported, the spacing of cable bolts across the opening, as well as row spacing, can be calculated. Using a cable with a capacity of 260 kN (58,600 lbf) and varying the number of cables across the opening and row spacing, a design can be determined for different thicknesses of rock that must be supported. Figure 13 shows this design chart for an effective width of 7.6 m (25 ft) and a rock density of 2,403 kg/m<sup>3</sup> (150 lb/ft<sup>3</sup>). This chart is based on a flat failure surface developing at the given horizon with the additional weight of material for the yield zone. A separation at 2.4 m (8 ft) would require four cables per row with 2.4-m (8-ft) row spacing. However, there are no safety factors calculated into these charts.

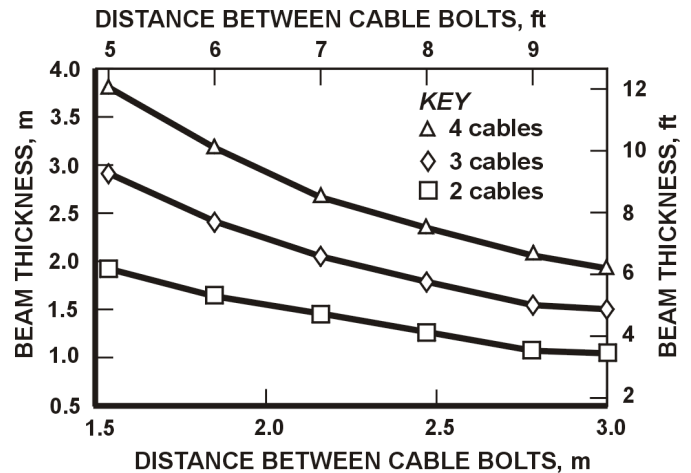
Figure 13. –Cable support design chart, where the effective width of opening ( $W_e$ ) = 7.6 m (25 ft) and rock density ( $\gamma$ ) = 2,403 kg/m<sup>3</sup> 150 lb/ft<sup>3</sup> [McDonnell et al. 1995].

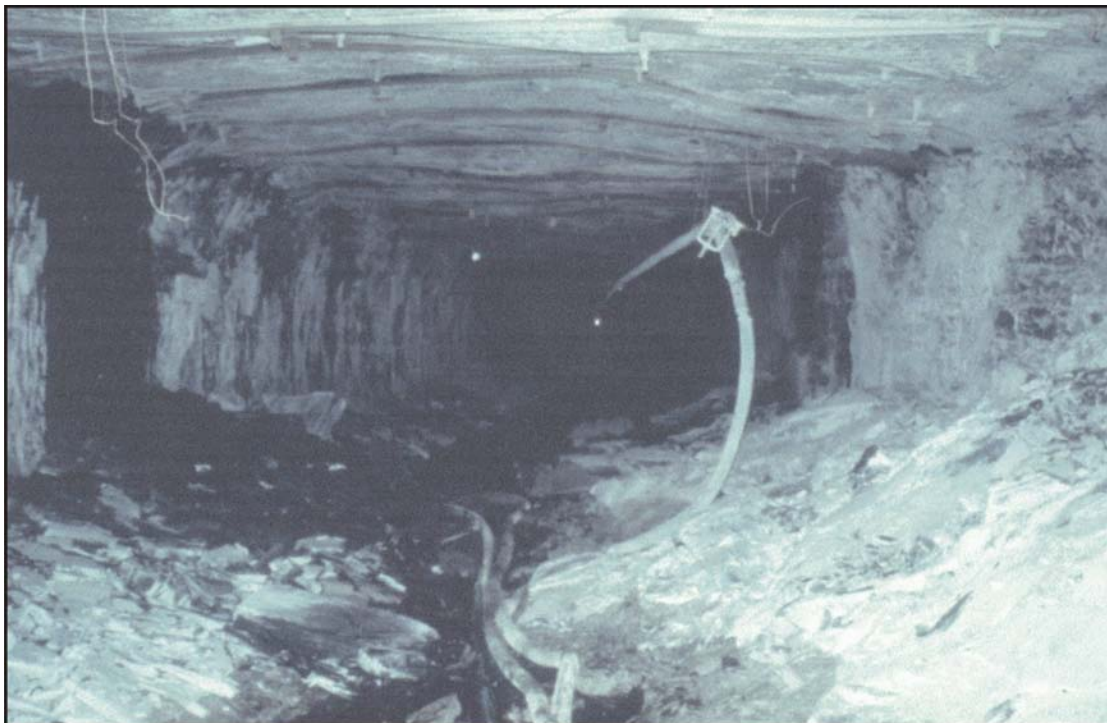
Figure 14.—Tailgate abutment zone outby the face supported with cable bolts.

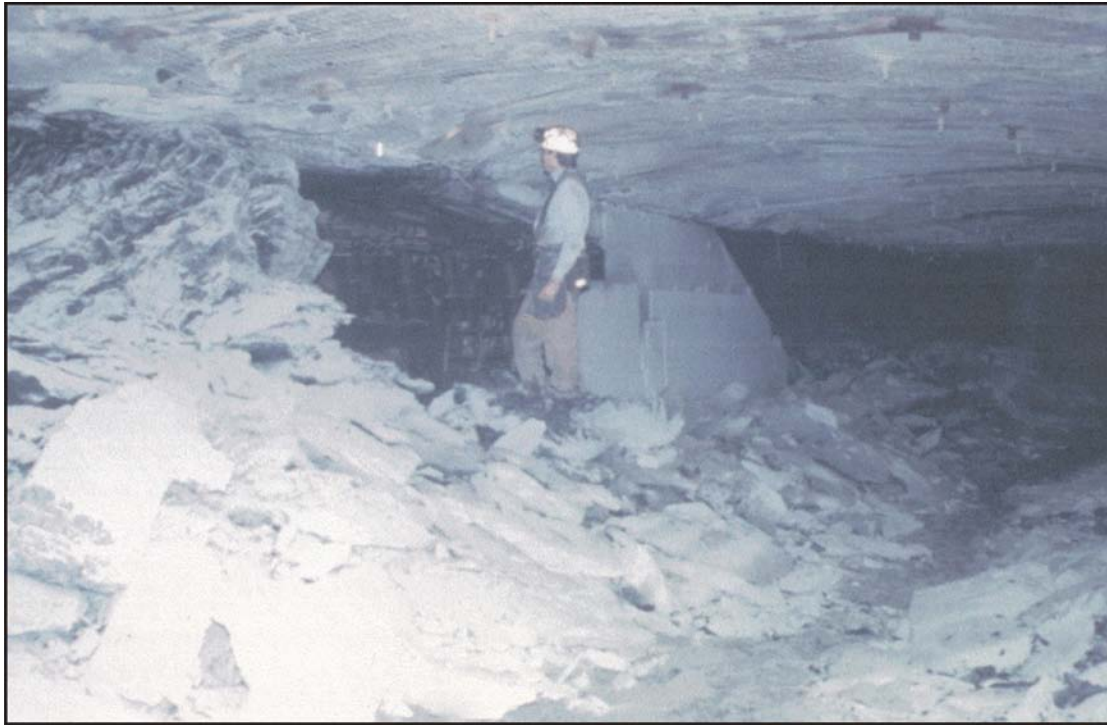
**Figure 15.—Tailgate shield zone supported by cable bolts.**

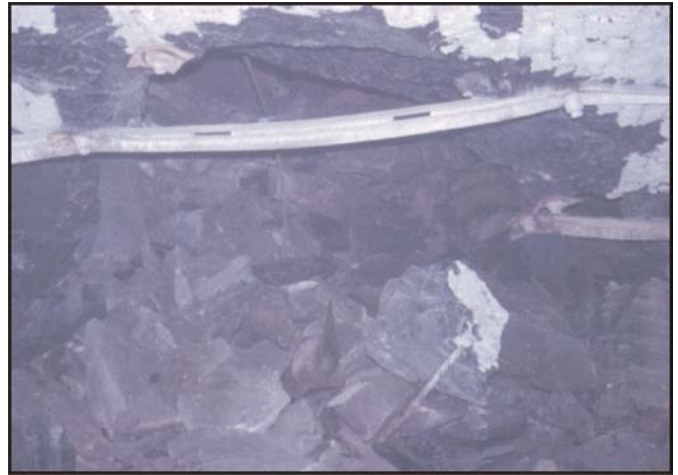
**Figure 16.—Tailgate behind the shields has caved though supported with cable bolts.**

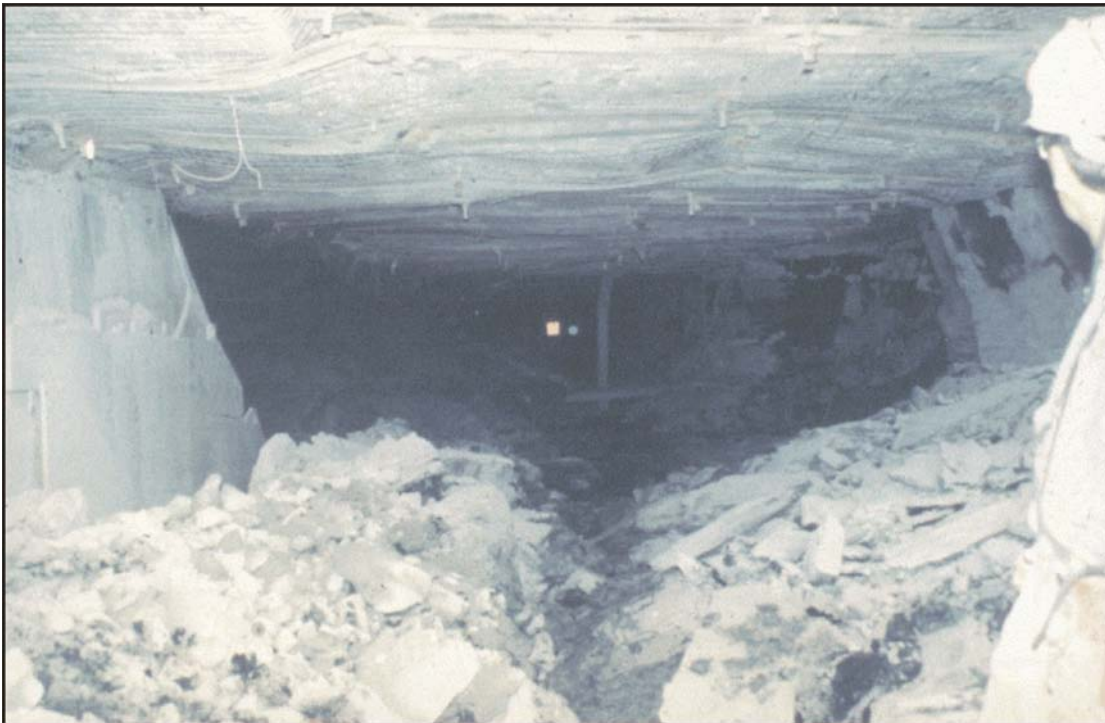
**Figure 17.—Tailgate behind the shields kept open with cable bolts.**

area is not a factor. However, in some mines, ventilation requirements necessitate that the gateroad be kept at least partially open to the nearest crosscut behind the face, a distance of usually 30 to 45 m (100 to 150 ft). The maintenance of this section of the tailgate by the cables is dependent to a large degree on the geology and the cave and only to a limited degree on cable system design. In the tailgate adjacent to the cave, the roof develops into a cantilever that must be supported. If the roof is not strong enough and the cave goes above the cables then the cantilever could fail and close most of the entry (figure 16). If the roof is strong enough to maintain the cantilever, then the cables will help to maintain any lower weaker roof. The critical factors are whether the cave develops above the cables and if the zone is strong enough to maintain the cantilever. The cables probably add little overall strength to the cantilever. However, there are cases where the entry has stayed open more than 45 m (100 ft) behind the face [Koehler et al. 1996; Martin et al. 1996; Mucho et al. 1996] (figure 17).

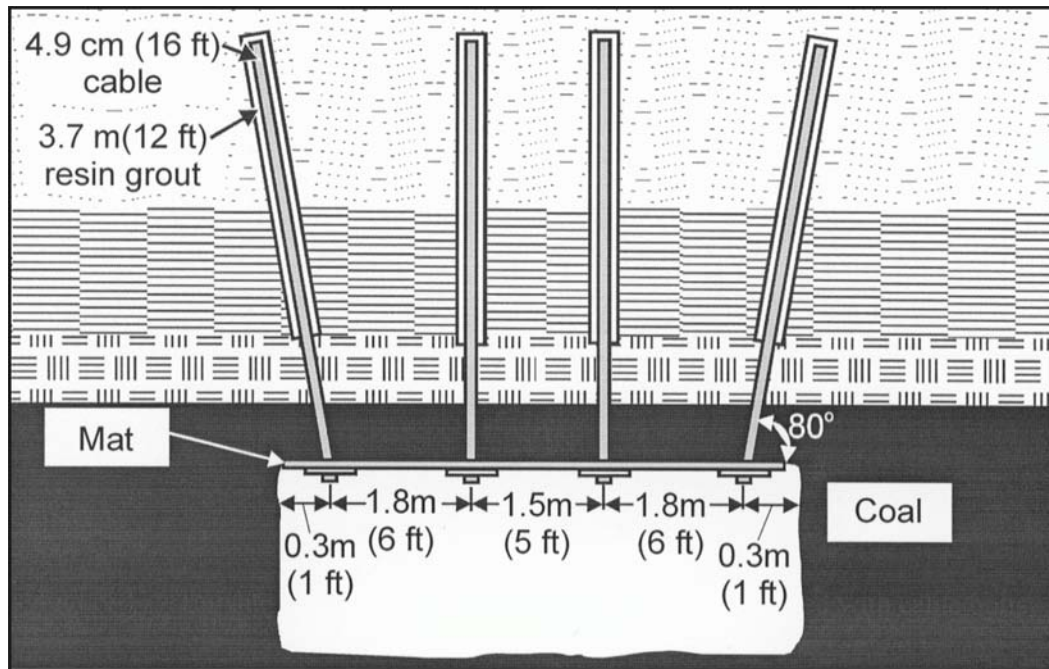
Figure 18.—Cross section of tailgate entry showing cable bolt design for case history 1.

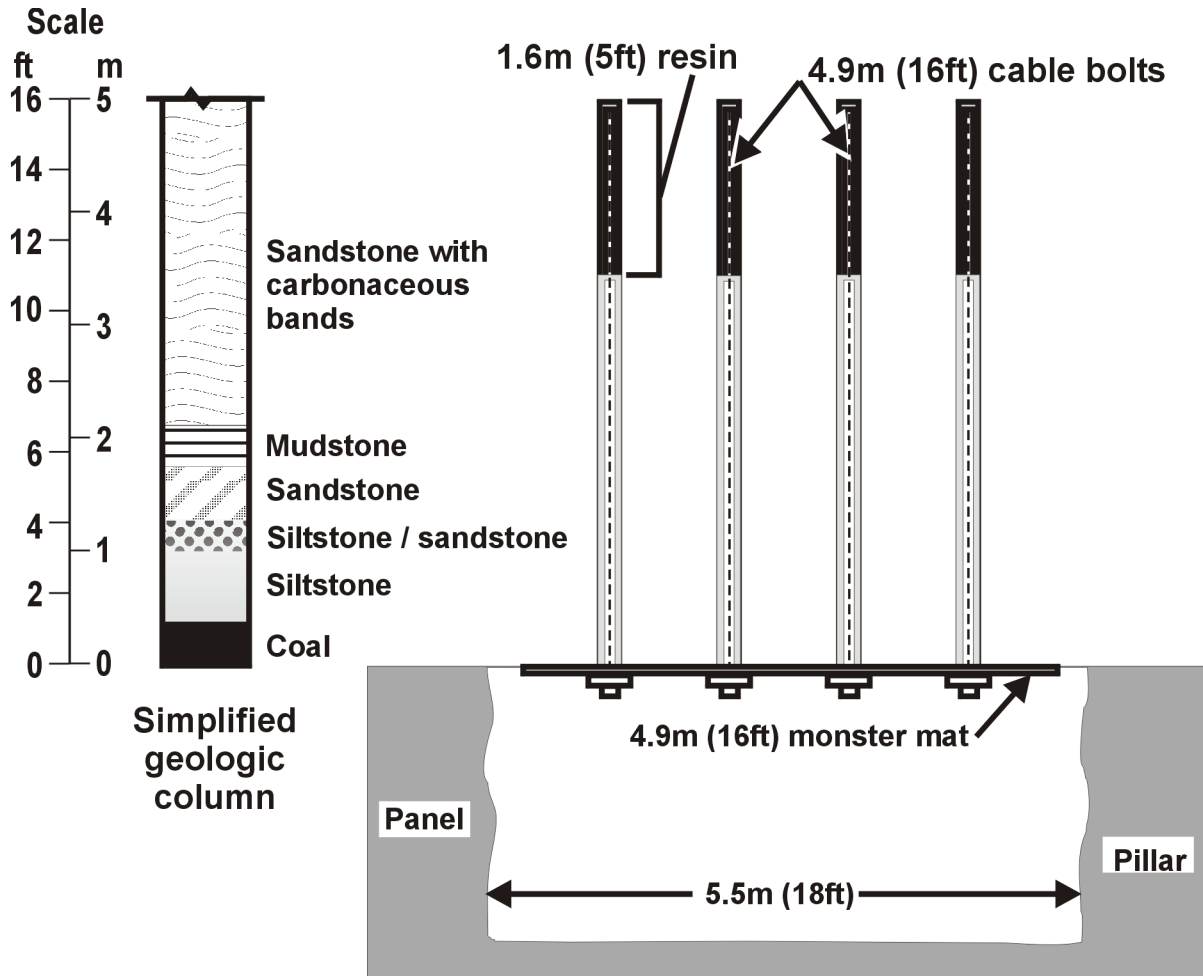
Figure 19.—Cross section of tailgate entry showing cable bolt design for case history 2.

Figure 19 shows the geology as well as a cross section of the entry with the cable system design. The cable bolts were 4.9 m (16 ft) long with four bolts per row and a row spacing of 1.5 m (5 ft). The resin anchor length was 1.5 m (5 ft), resulting in a free cable length of 3.4 m (11 ft). This free cable length allowed for greater cable elongation in the high-stress and deformation environment caused by crushing of the yield pillar. This cable system design would support a roof thickness of up to 3.3 m (10.9 ft) based on a dead weight load.

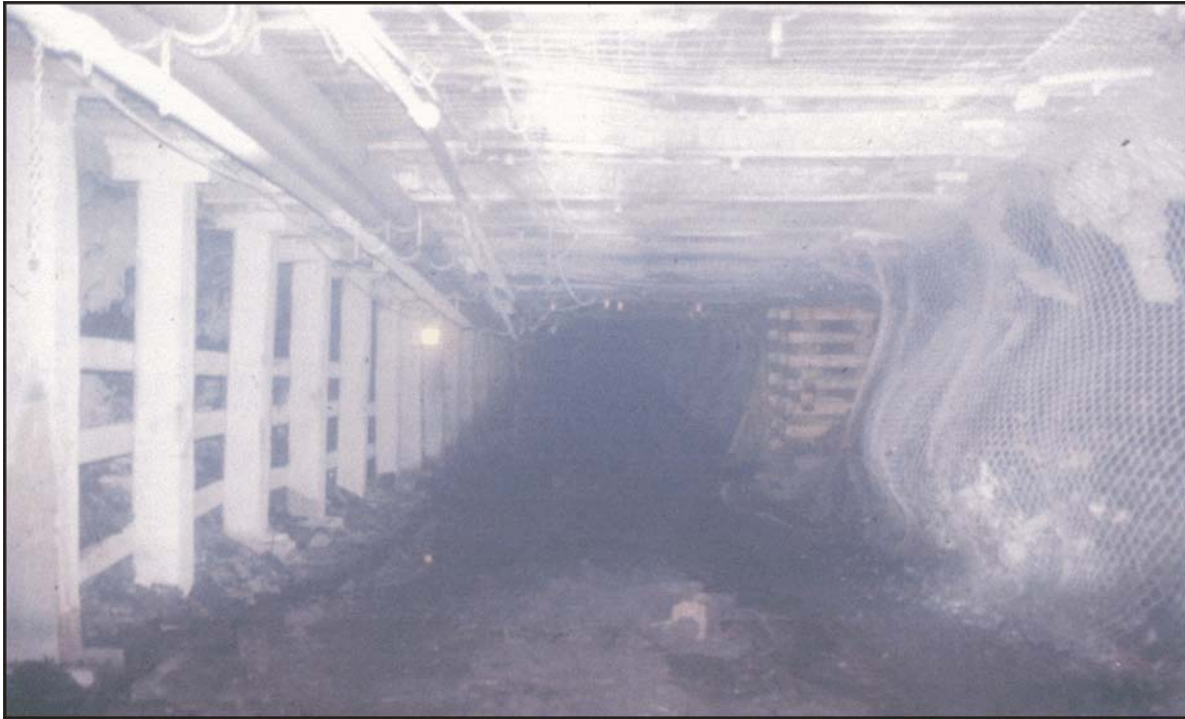
**Figure 20.—Two entry yield pillar tailgate showing the abutment zone outby the face, supported with cable bolts**

this differential movement, and some standing support was added. Separations were observed in the mine roof, but never above the anchor horizon. Up to 10 cm (4 in) of overall roof separation was seen, most of which occurred between the mudstone-sandstone layers within the lower 1.2 to 1.8 m (4 to 6 ft) of the roof. This was within the elongation capacity of the cables. However, cable loads up to 275 kN (40,000 lbf) and cable failures indicated that this level of elongation was approaching the limit of the cable system especially as it was developed by shear. Despite this high-deformation environment, the tailgate was kept open and functional with the cable support even under the sandstone channels (figure 20).

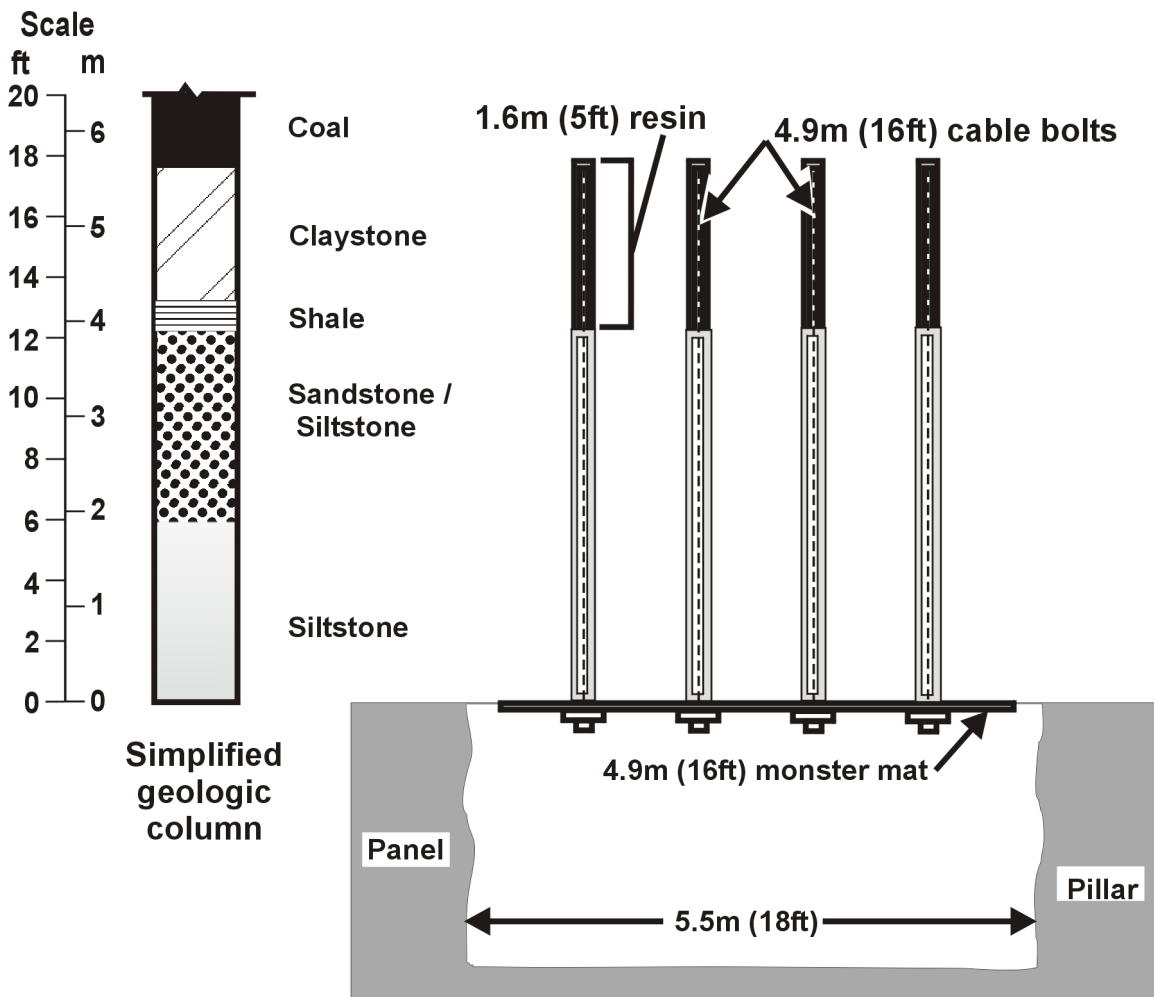
Figure 21.—Cross section of tailgate entry showing cable bolt design for case history 3.

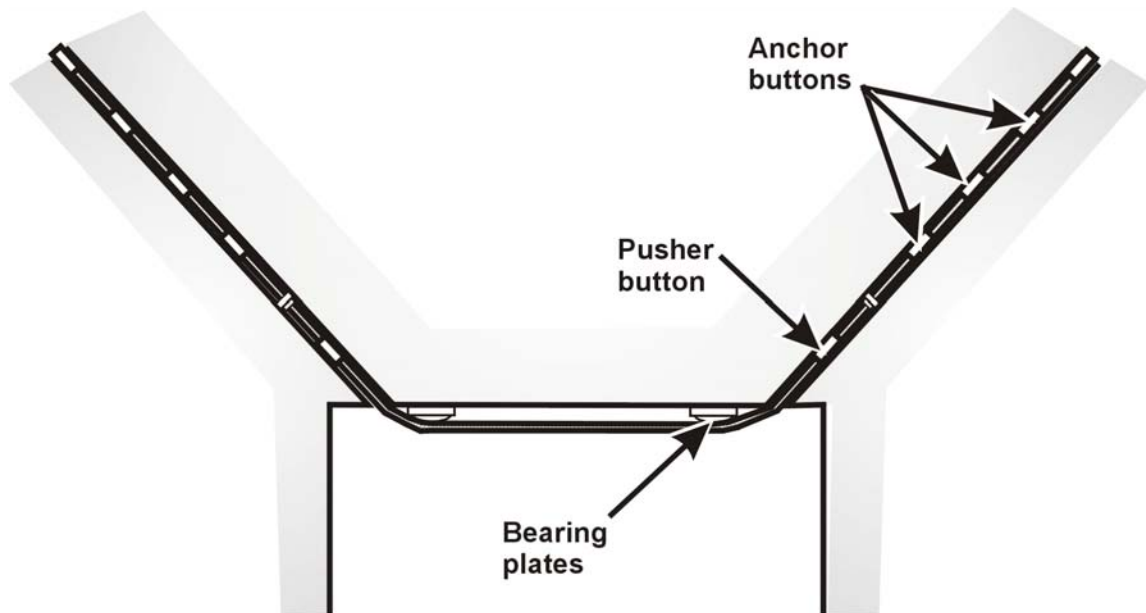
Figure 22.—Single piece cable truss.

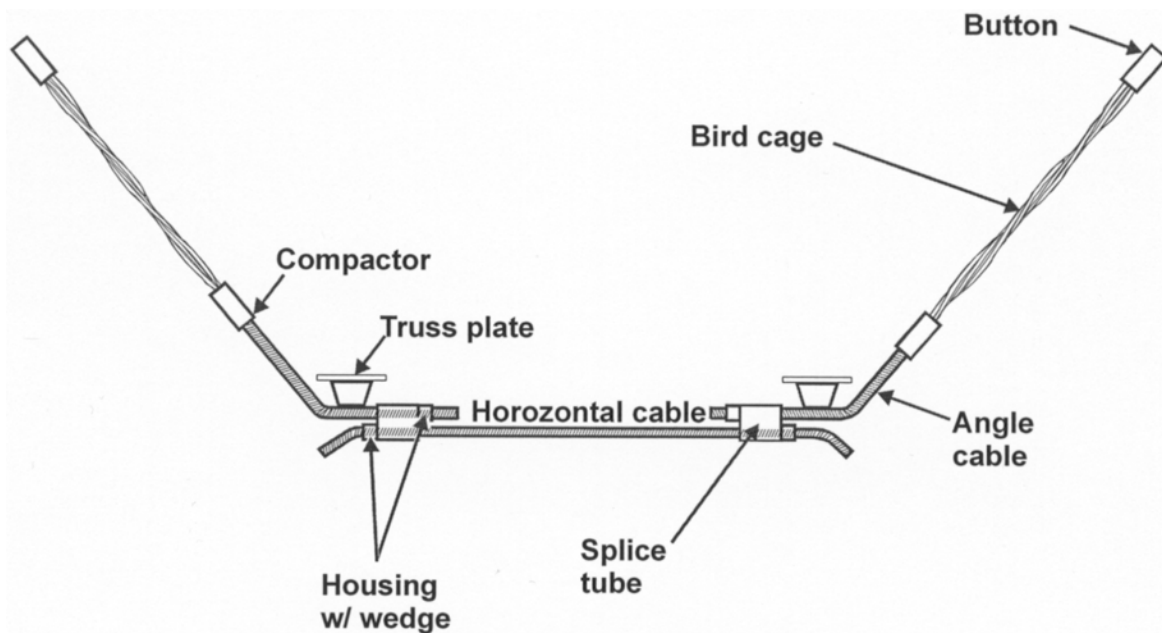
Figure 23.—Three piece cable truss.

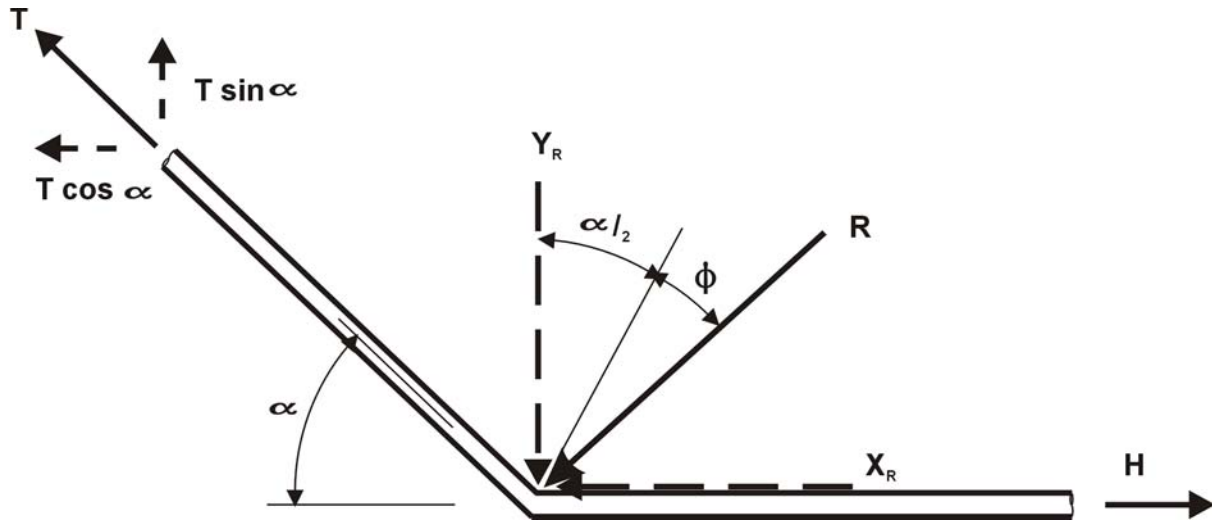
Figure 24.—Free body diagram of half truss showing the truss loads.

The loads developed in a truss can be evaluated by simple statics. Figure 24 shows a simple free-body diagram of the loads for a half of a truss. The following equations can be used to describe the relationship between the reaction force  $R$  broken into horizontal and vertical components and the cord tensions.

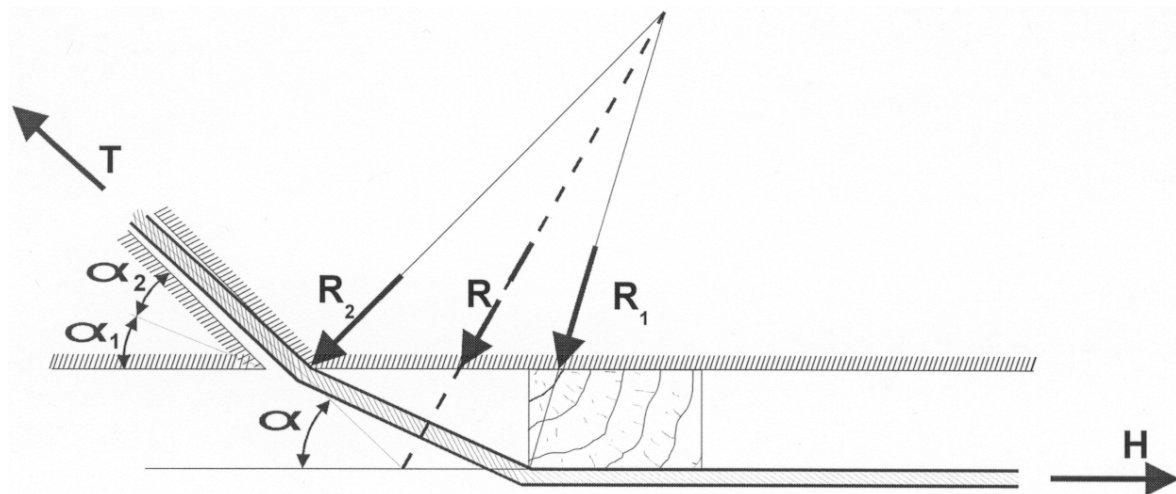
Figure 25.—Free body diagram of half cable truss, showing static loads that develop.

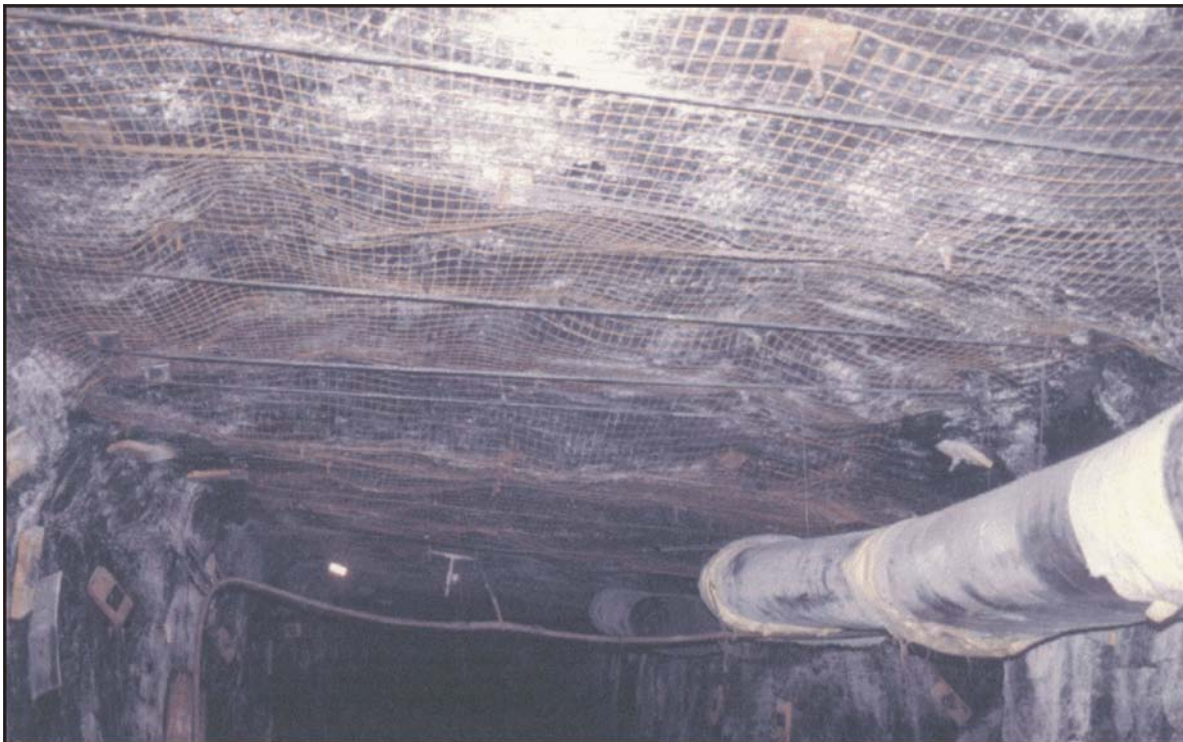
Figure 26.—Cable trusses installed in the headgate entry.

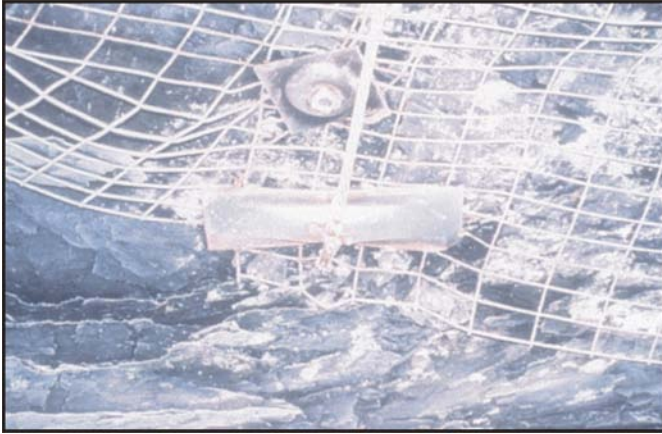
**Figure 27.—Roof damage from horizontal stress around cable truss in headgate just outby the face.**

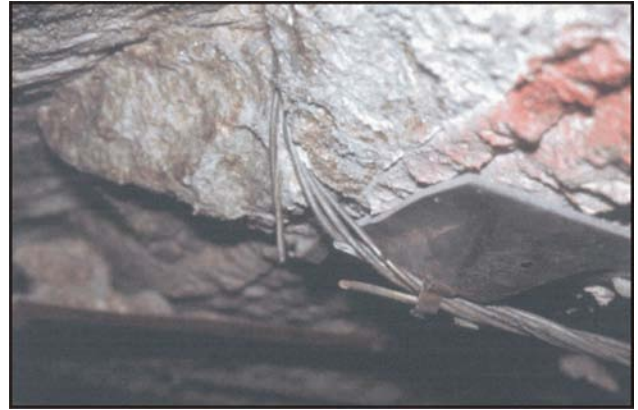
**Figure 28.—Shear failure of cable truss near bearing plate.**
